TOYOTA

BE-01245T-TME

## Technical Service Bulletin

### TOYOTA TOUCH 3 (TAS600 Entry DA) - Software fixes - Running Change 2

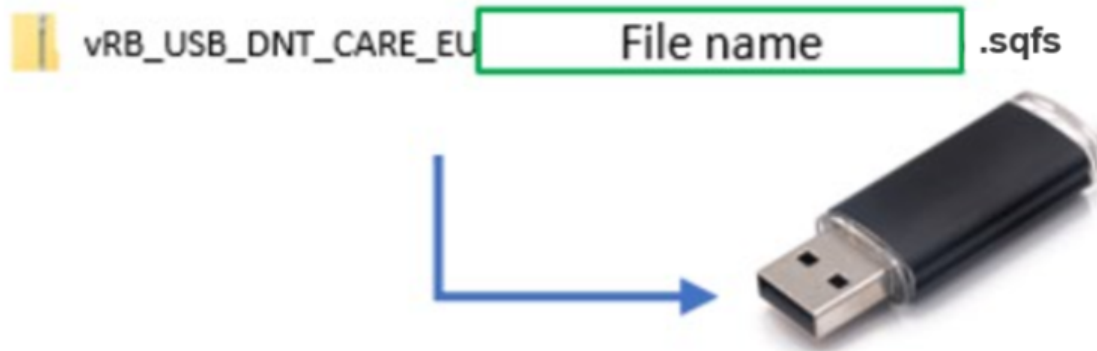
Prepare the USB stick.

1. Use a USB drive which is formatted in FAT32 filesystem with at least 1 GB of capacity.
2. Download the [update package](#) (.sqfs file) and place it onto the root folder of the USB drive.

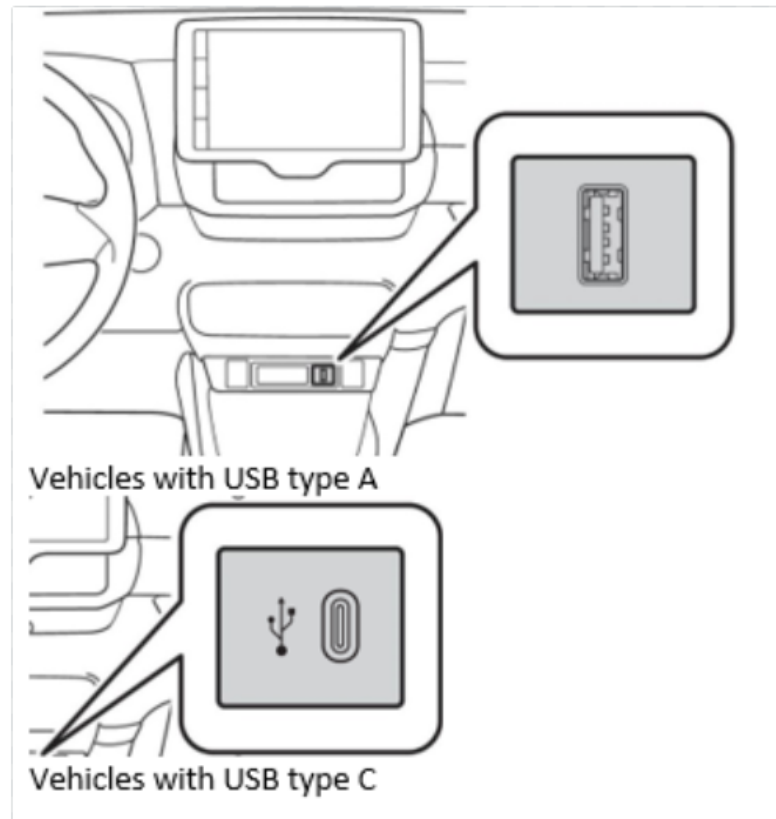
Detect the software update.

1. Insert the USB drive into the USB port of the audio system (USB-A or C depending on the model).

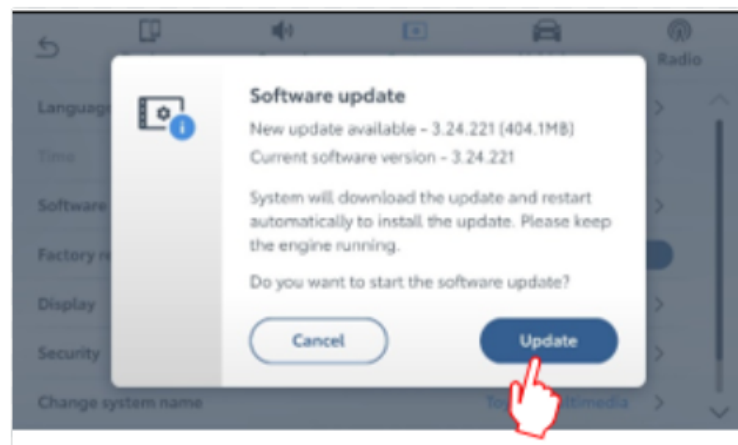
3. A pop-up will appear for user to start the software update.
4. Click on "Update".

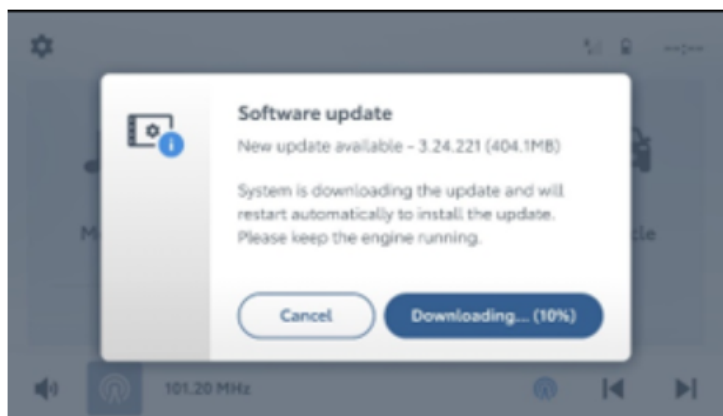
5. The software package will start the download process. No other action is required from user.

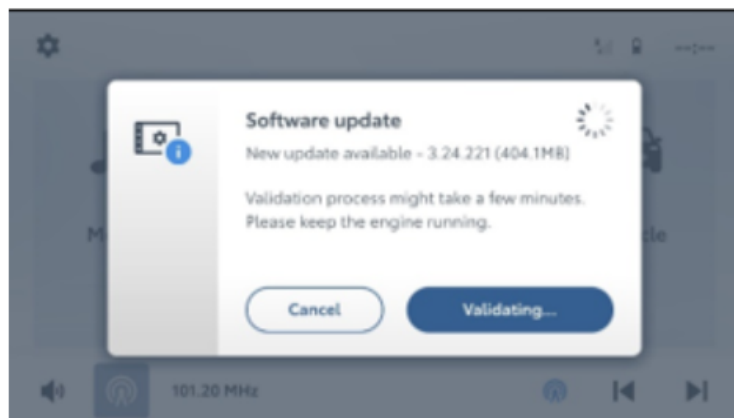
6. Once the download reaches 100%, a validation of the software update will happen, after which the head unit will restart.

After the validation, the installation will take around 10 min.

During the installation, the system cannot be used.

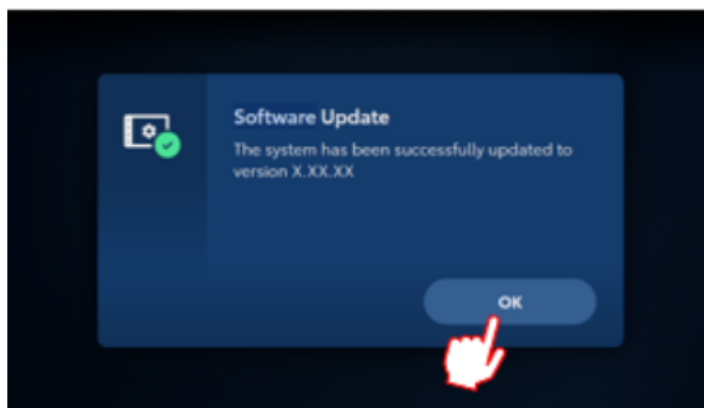
7. Once head unit has restarted, the user will see a success message on the screen. Press OK to close the pop-up and continue using the system.

8. Check in the pop-up message that the version is :3.24.252

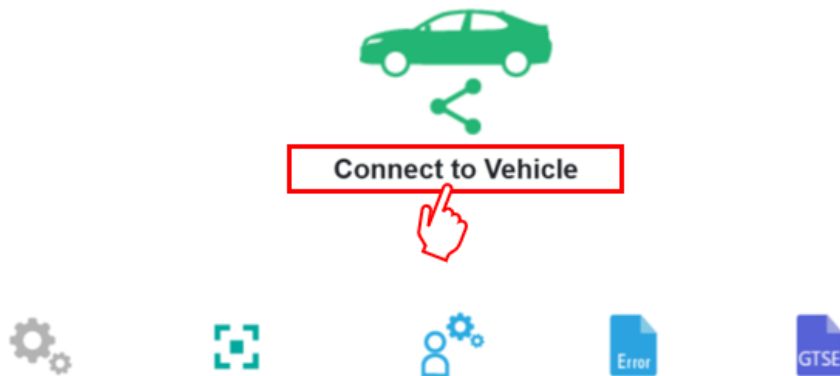
- Once logged into the GTS+ tool, you are ready to connect to the vehicle.

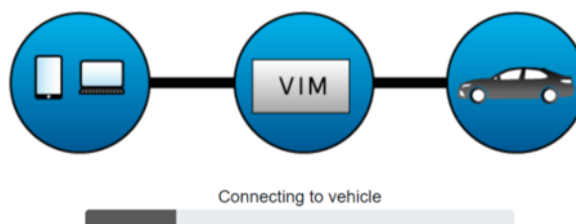
## Vehicle Connection

- You will see the connection in progress screen.

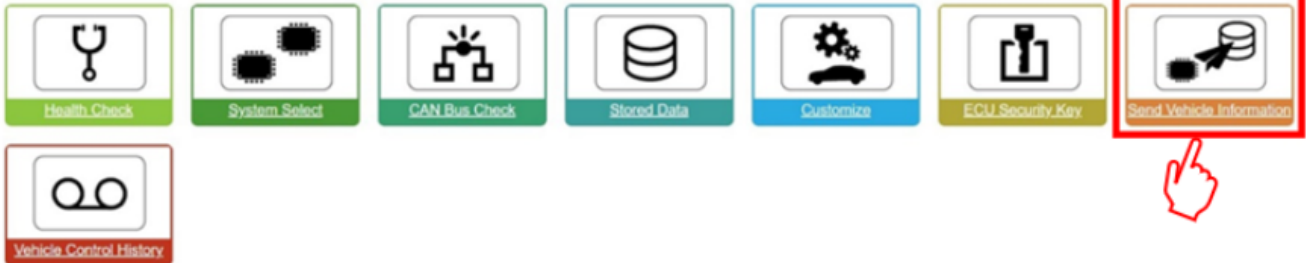
### Main Menu

- After selecting options, wait for GTS+ to complete the connection to the vehicle.
- Once connection is established, you will see the “Main Menu” screen.
- Press on “Send Vehicle information”.

- Press on next to continue the process.
- Follow the instructions given by GTS+ (you will be required to login again during the this process).
